# Environmental Condition of Property

**Buildings 130H, 129H, 128H: Corps School  
Property Lease for Charter School  
601 D Street  
Great Lakes, IL 60088**

Prepared August 2011 by NAVFAC Midwest IPTEV

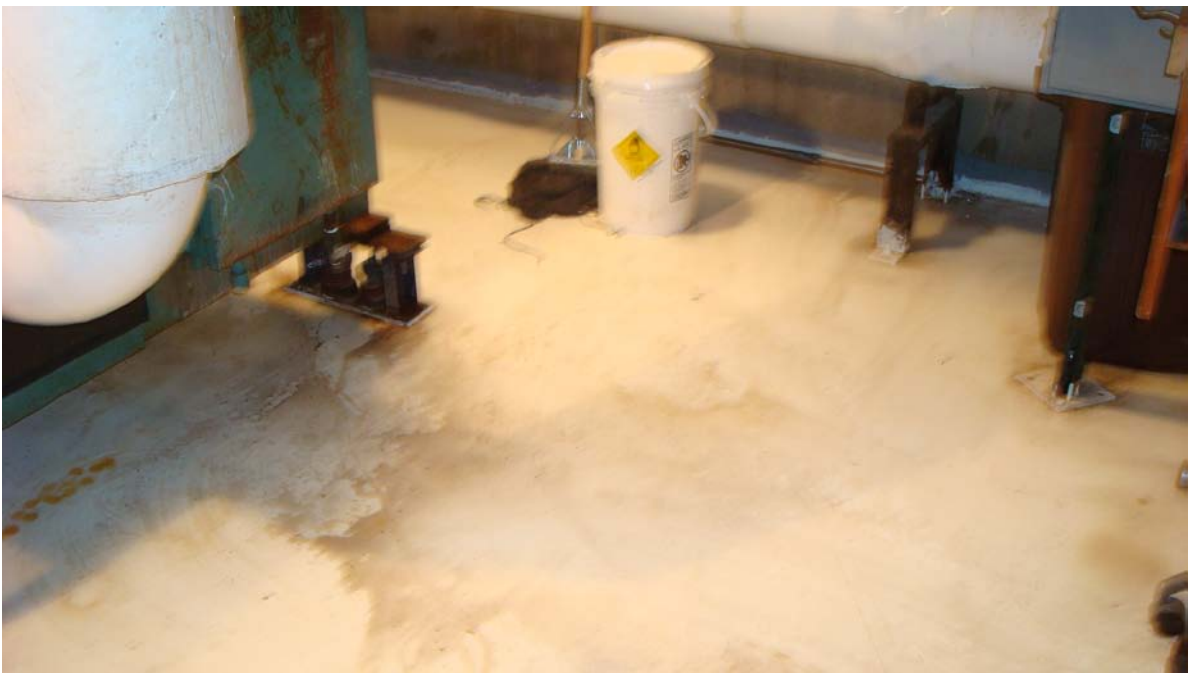
Historical uses of the property, Environmental FirstSearch Report, site visit by NAVFAC MW IPTEV Personnel and interview with site personnel do not indicate any contaminant storage, use, or disposal on site. There is standing water in Building 129H laundry room and mechanical room, Building 128H mechanical room, and Building 130H penthouse that pose mold risks.

**Figure 4 – Water on floor from leaking HVAC unit in Penthouse in Building 130H**

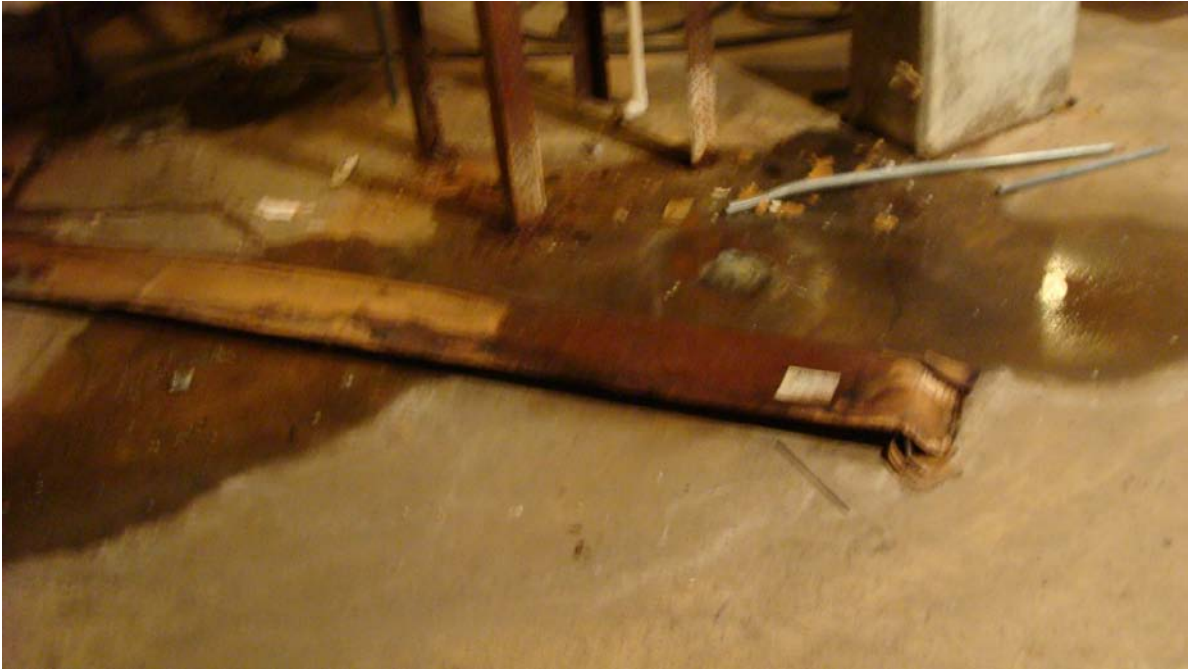
**Figure 5 – Water in Building 128H Mechanical Room which poses a mold problem**

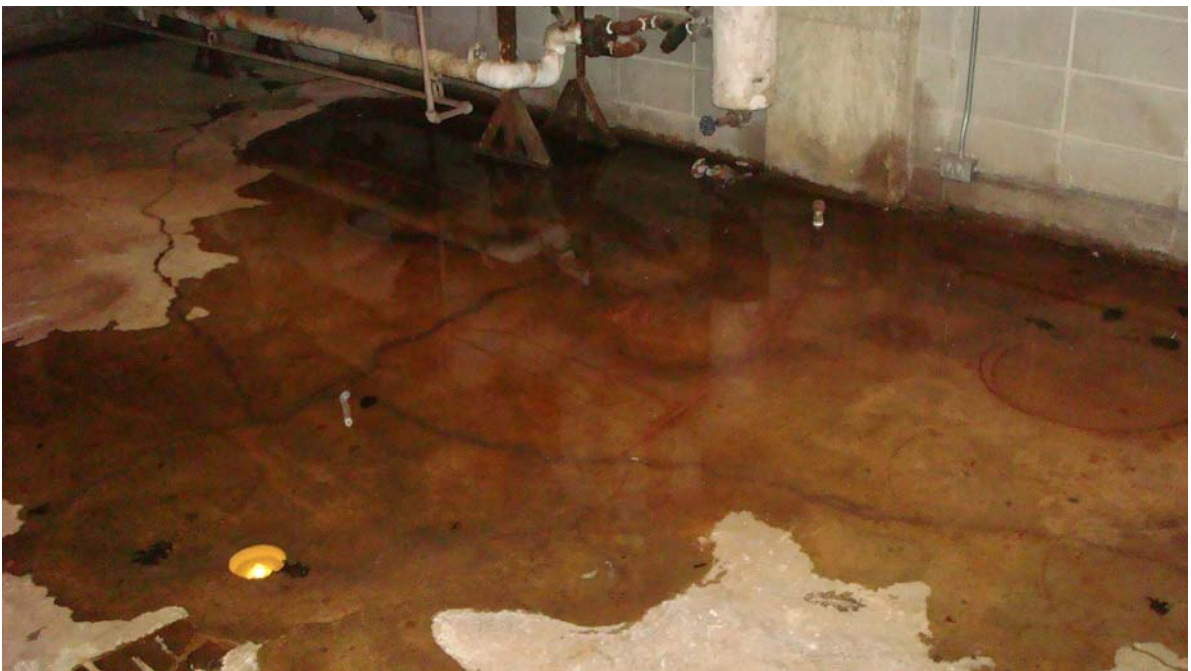
**Figure 6 – Water in Building 129H Mechanical Room which poses a mold problem**

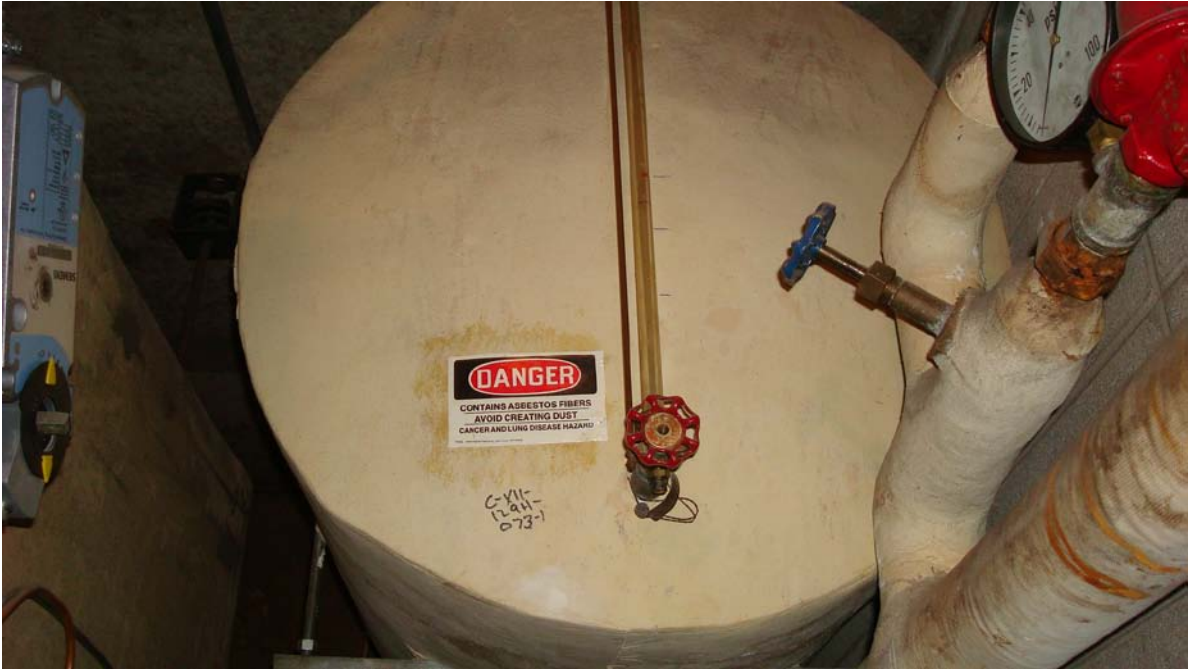
Building 128H contains pipe fitting insulation on fiberglass pipes throughout the building that tested positive for ACM and tank end caps near room 318 that tested positive for ACM. Prior to demolition or renovation of Building 128H ACM must be remediated.

**Figure 7 - Bldg 128H Asbestos in Fan Room**

Due to the presence of ACM in the Buildings any demolition or renovation must be cleared by PWD Great Lakes Environmental, or have a complete asbestos survey completed and any ACM

remediated prior to commencing any activities that may potentially disturb the ACM located in the buildings.

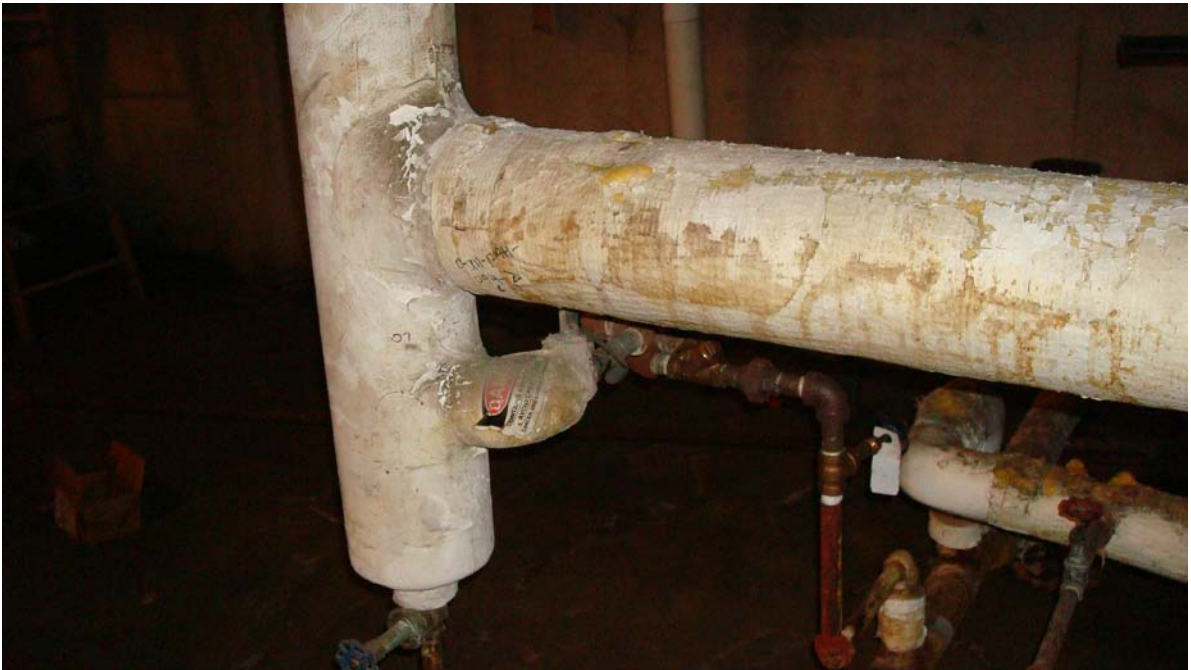
Building 129H contains the following that tested positive for ACM: 100 fittings on insulation on fiberglass pipes throughout the building, 50,000 square feet of textured plaster on the 3<sup>rd</sup> floor ceiling, 20 linear feet of vibration cloth on HVAC equipment next to room 373, and tan floor tile with mottled specks on the 1<sup>st</sup>, 2<sup>nd</sup>, and 3<sup>rd</sup> floors. Prior to demolition or renovation of Building 129H ACM must be remediated.

**Figure 8 - Building 129H Asbestos fittings in Mechanical Room**
